CERTIFICATE OF APPROPRIATENESS

Property: 623 Highland Street, Lot 11, Tract 10, Block 30, Woodland Heights Subdivision. The property includes a historic 2,135 square foot, one-story wood frame single-family residence and detached garage situated on a 7,500 square foot (75' x 100') interior lot.

Significance: Contributing Center Hall Victorian Cottage residence, constructed circa 1900, located in the Woodland Heights Historic District.

Proposal: Alteration – The applicant was denied a COA by the Commission at the February 13, 2014 HAHC meeting, to replace 17 original 1-over-1 wood sash windows with 17 new composite sash windows. The applicant has resubmitted the application to replace 17 original 1-over-1 wood sash windows with 17 new 1-over-1 composite sash windows within the same openings.

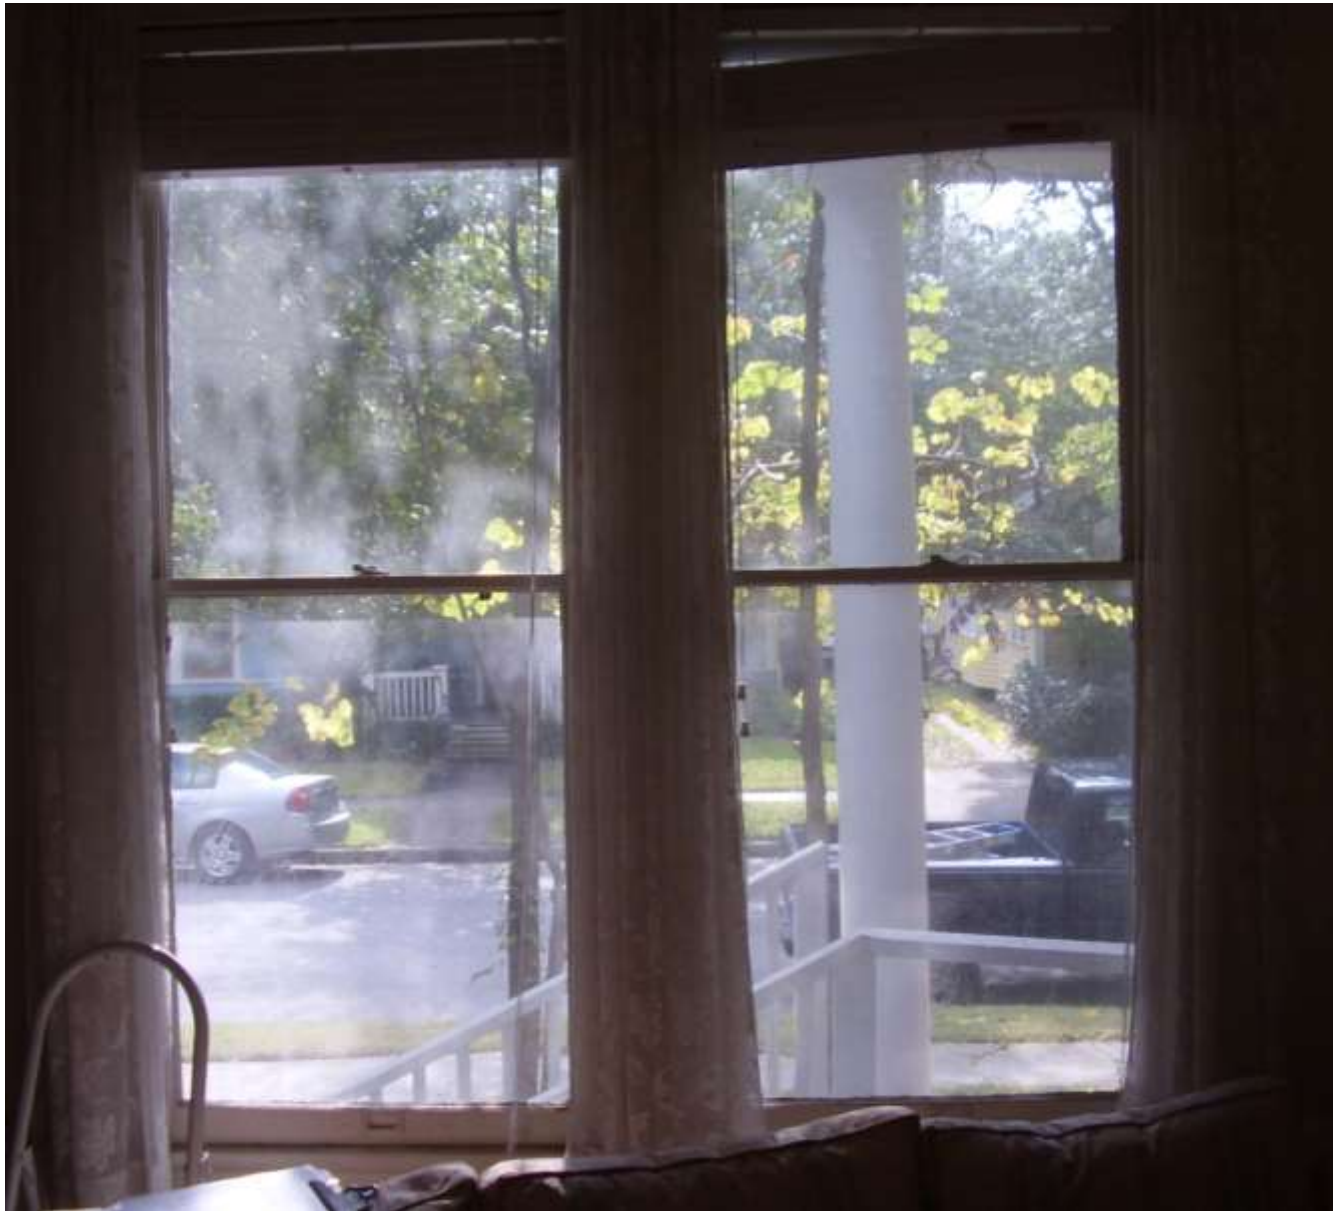
Windows 102 & 103

Unit #102 Living Room – Lead paint is peeling, Sash are rotted. Damaged beyond repair, window does not open.

Unit #103 Living Room - Sash are rotted Lead Paint is peeling, window cannot be locked and is out of square. Check rail does not align

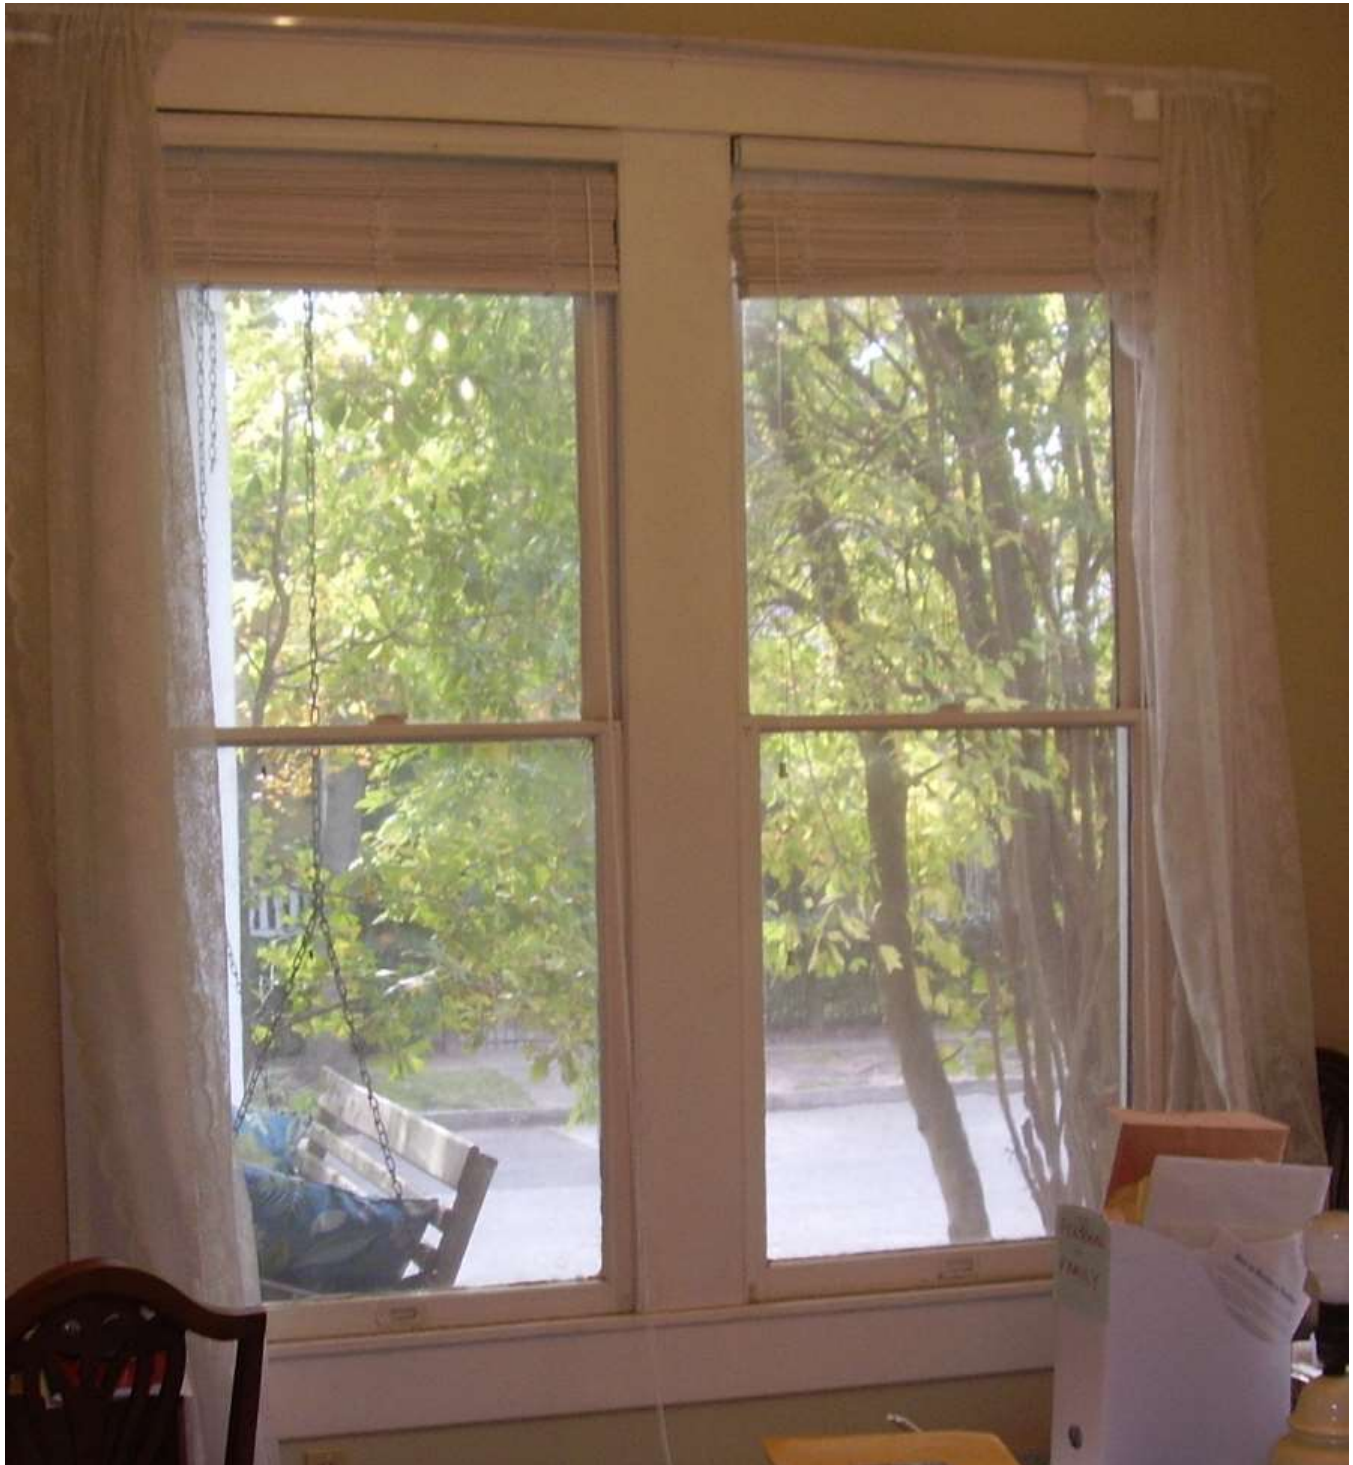
Windows 104 & 105

Unit # 104 Dining Room - Sash are rotted Lead Paint is peeling, window cannot be locked and glass is cracked.

Unit # 105 Dining Room - Sash are rotted, Lead Paint is peeling. Window cannot be locked. Check rail does not align.

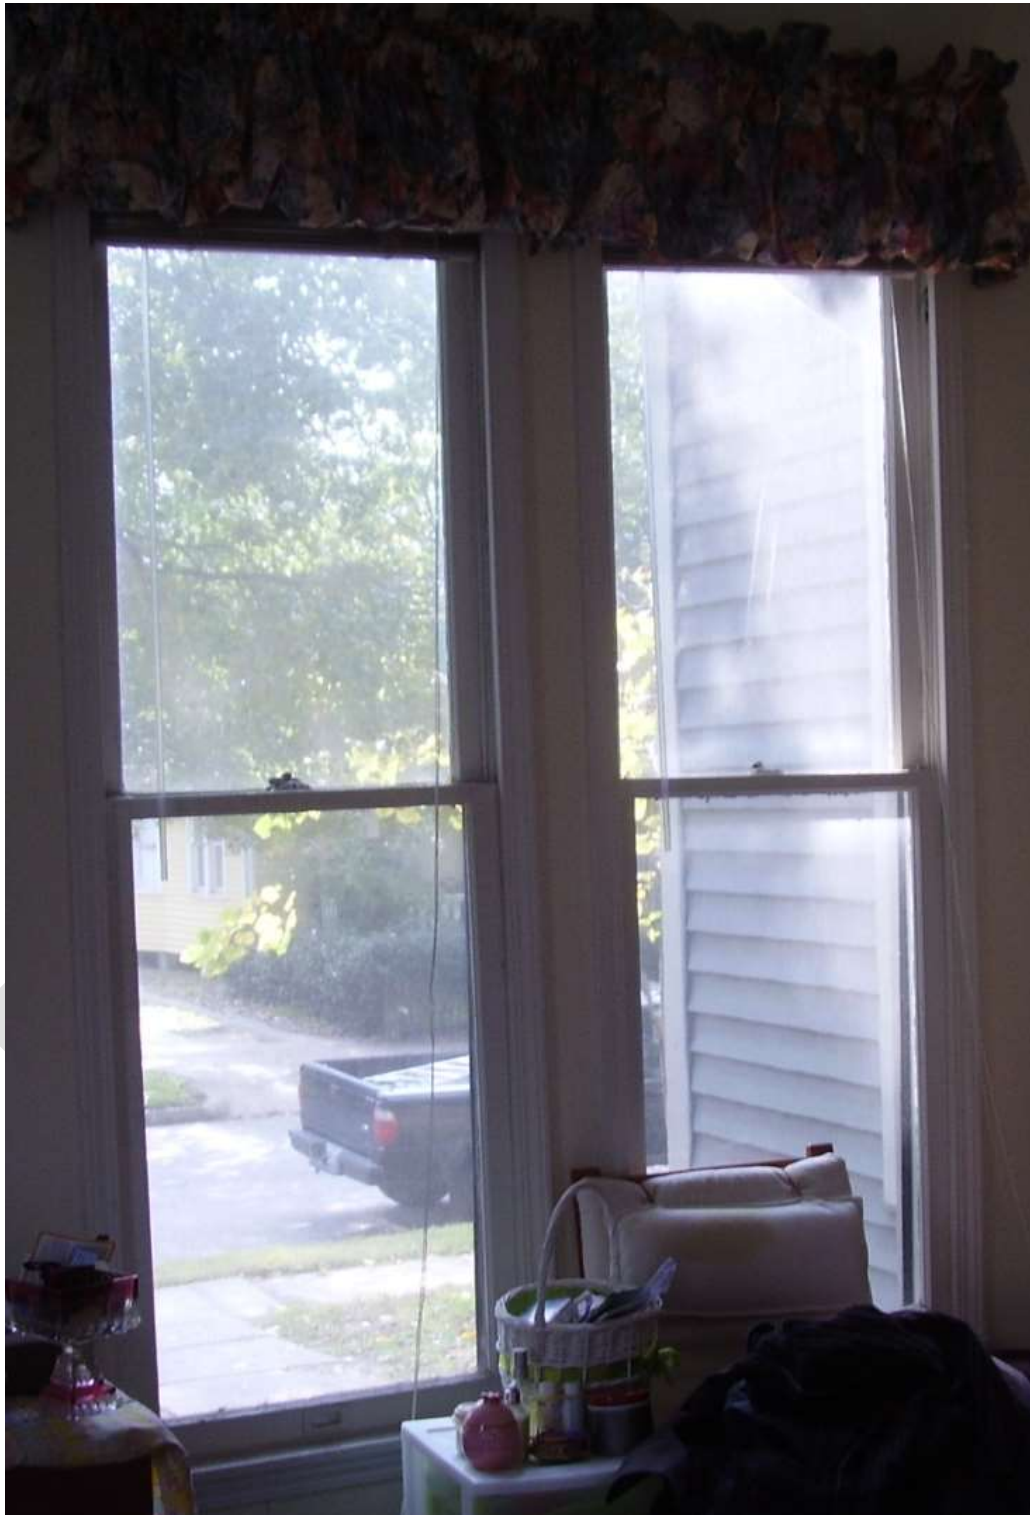
Windows 117 & 118

Unit # 117 Bedroom 3 - Sash are rotted, lead paint is peeling. Window does not open as designed. Window does not close completely as indicated in the accompanying photo. Check rail does not align.

Unit # 118 Bedroom 3 – lead paint is peeling, Sash are rotted. Window does not open as designed. Check rail does not align.

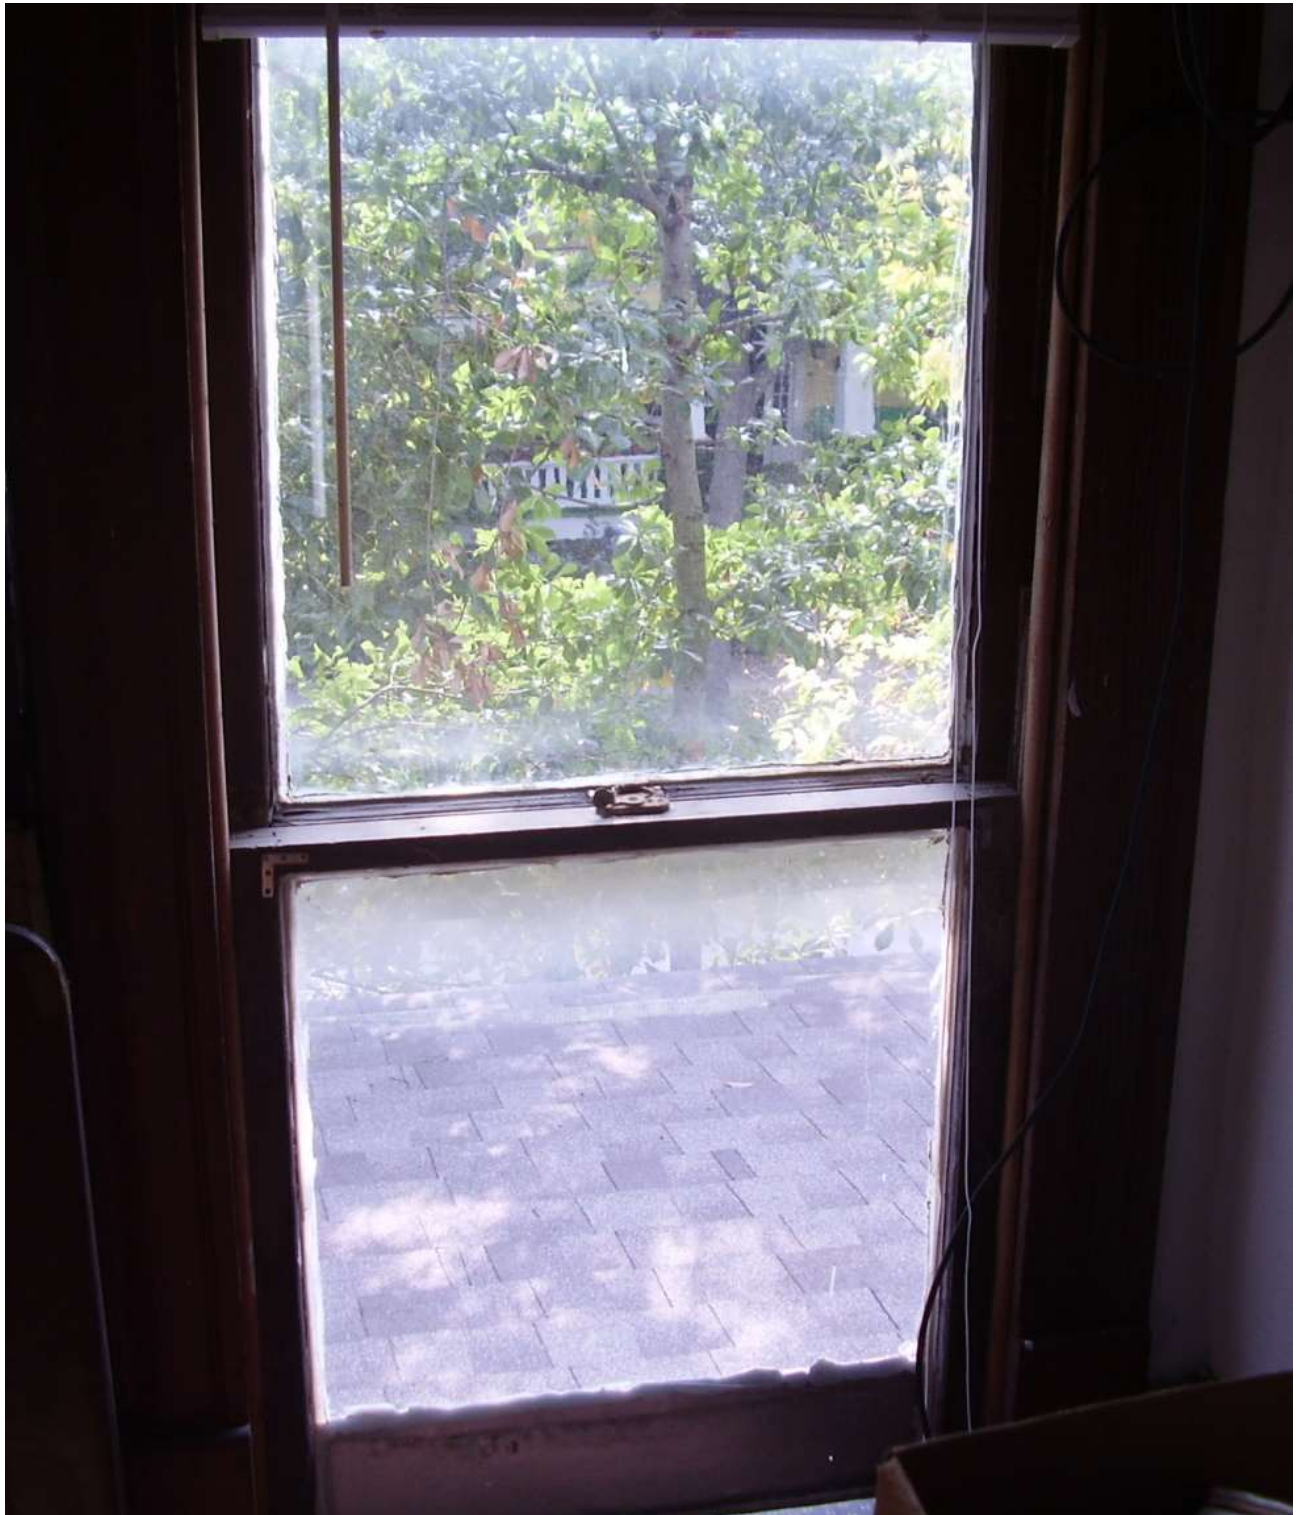
Window 222

Units # 222 Attic – lead paint is peeling, Sash are rotted. Damaged beyond repair. Window does not open. Lead paint has flaked off and continues to flake off due to UV exposure and degradation of the original wood.

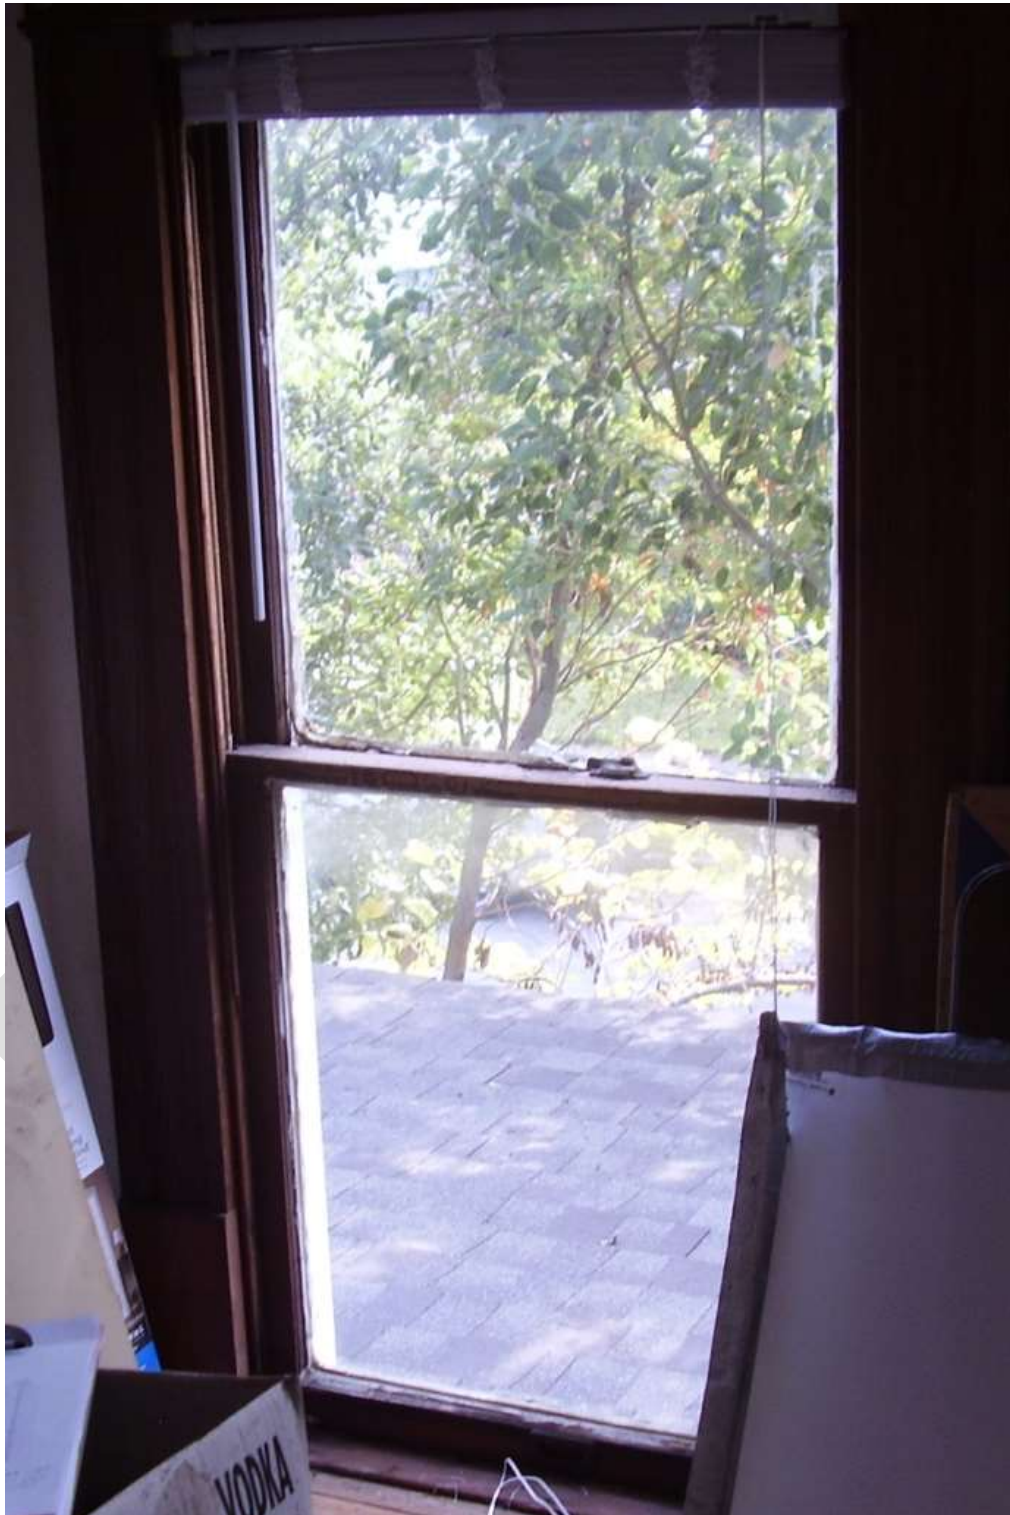
Window 223

Unit # 223 Attic Bedroom – Sash are rotted, lead paint is peeling. Damaged beyond repair, Window does not open and Window glass is broken and has plywood in the place of glass. Water has intruded causing massive damage to the original hardwood attic floor and potentially the floor joist.

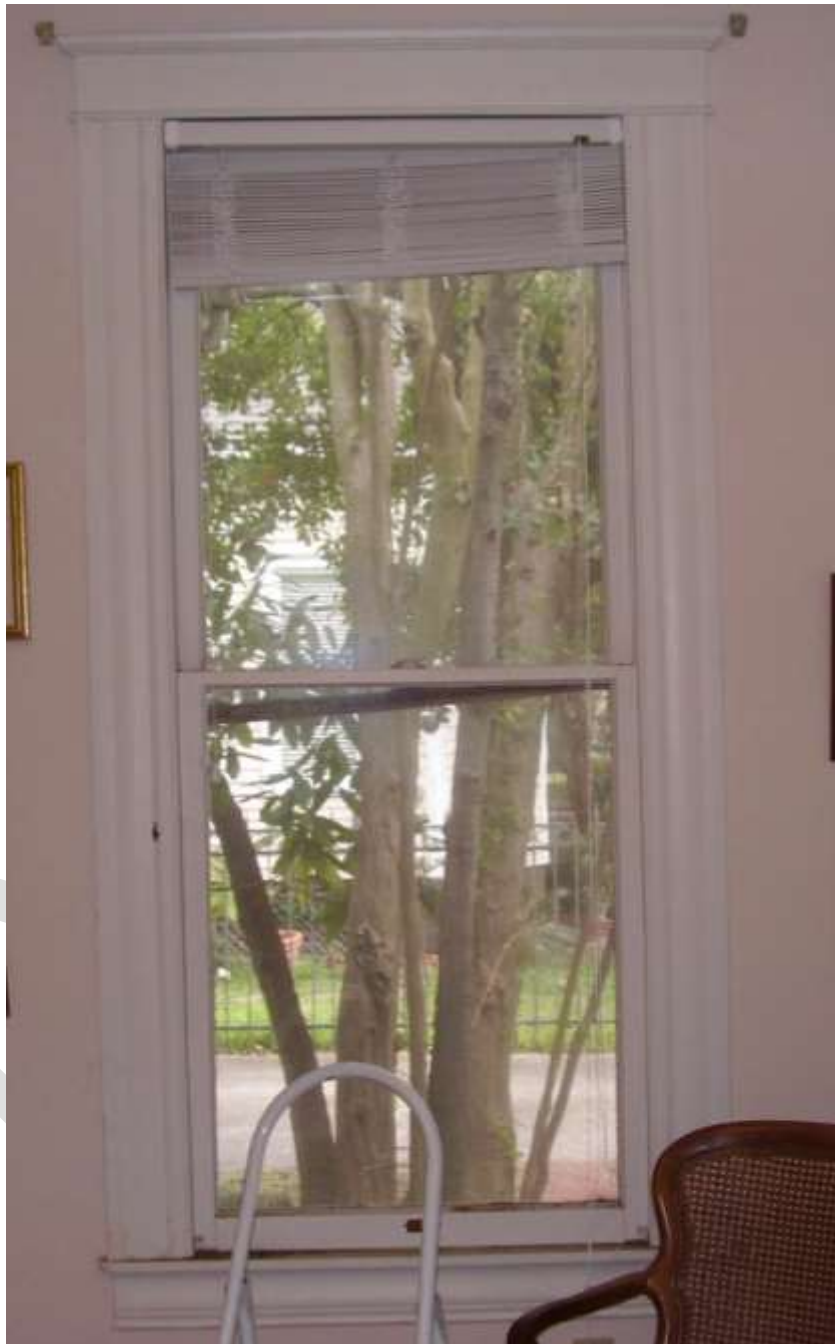
Window 101

Unit #101 Living Room – Sash are rotted, lead paint is peeling. Window will not lock or close all of the way. Opening had to be boarded up in order to attempt to keep the elements out and provide security.

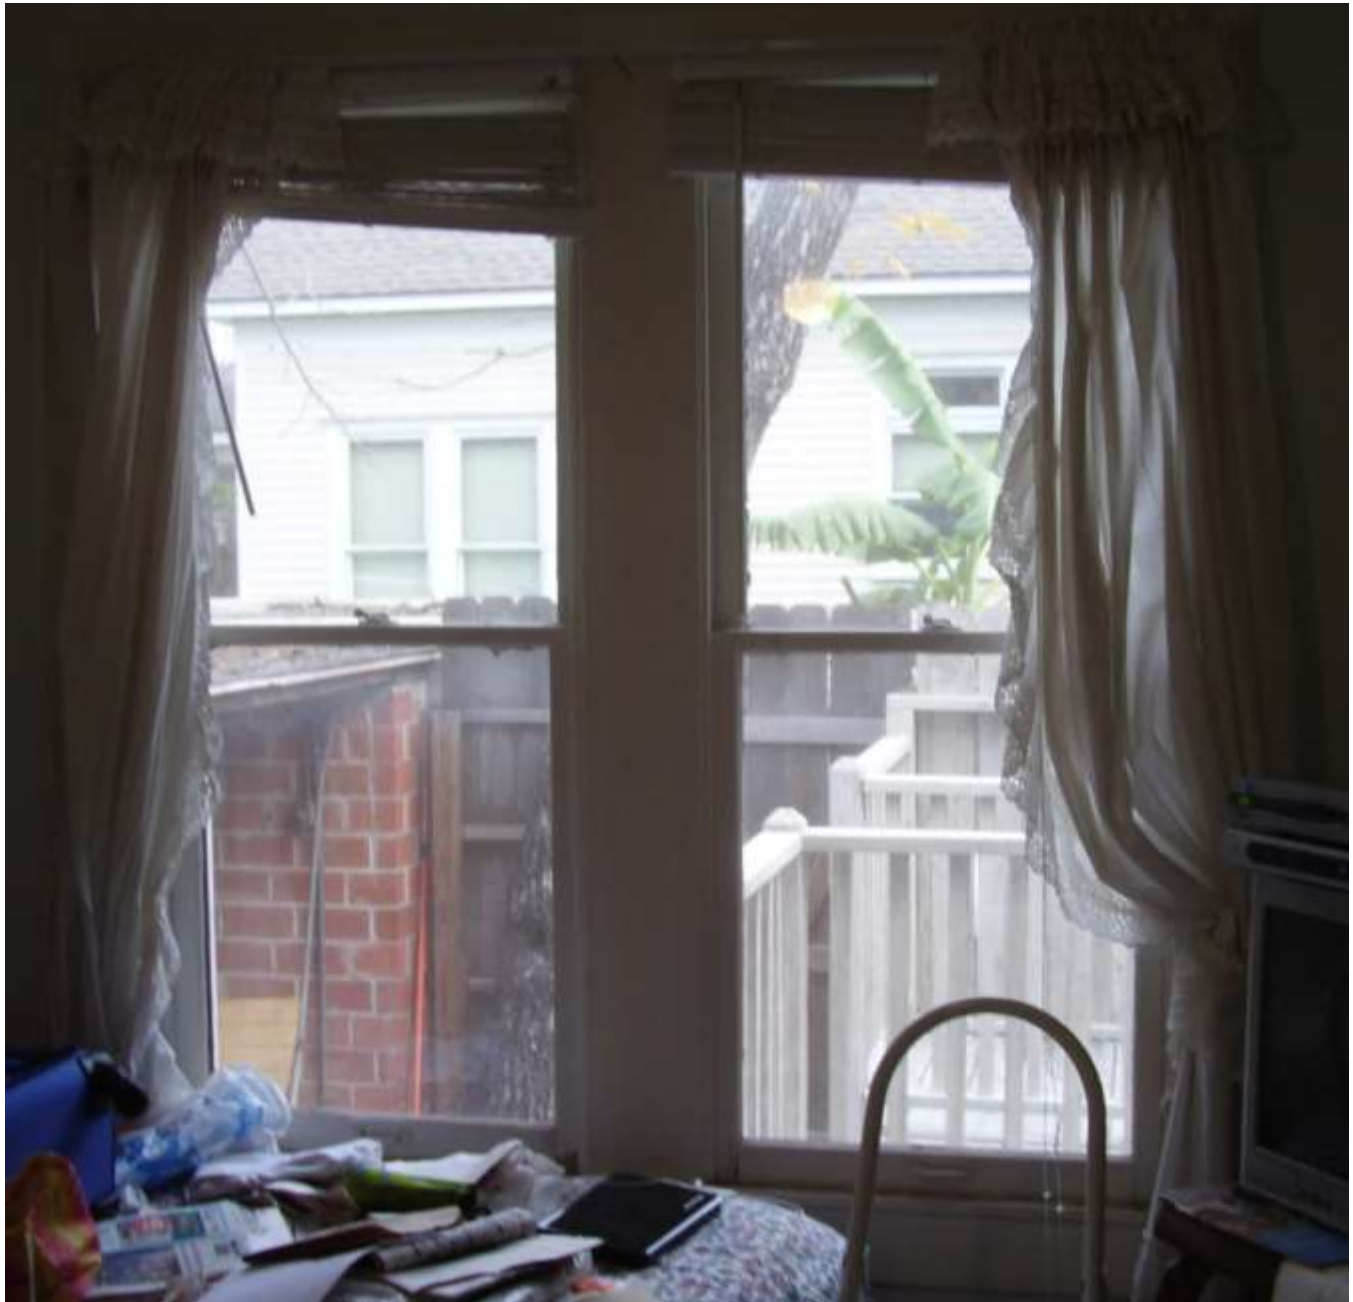
Windows 114 & 115

Unit # 114 Bedroom 1 – Sash are rotted, Lead Paint is peeling. Window cannot open (Fire Hazard egress Issue)

Unit # 115 Bedroom 1 – Lead paint is peeling, Sash are rotted. Window cannot open (Fire Hazard egress Issue)

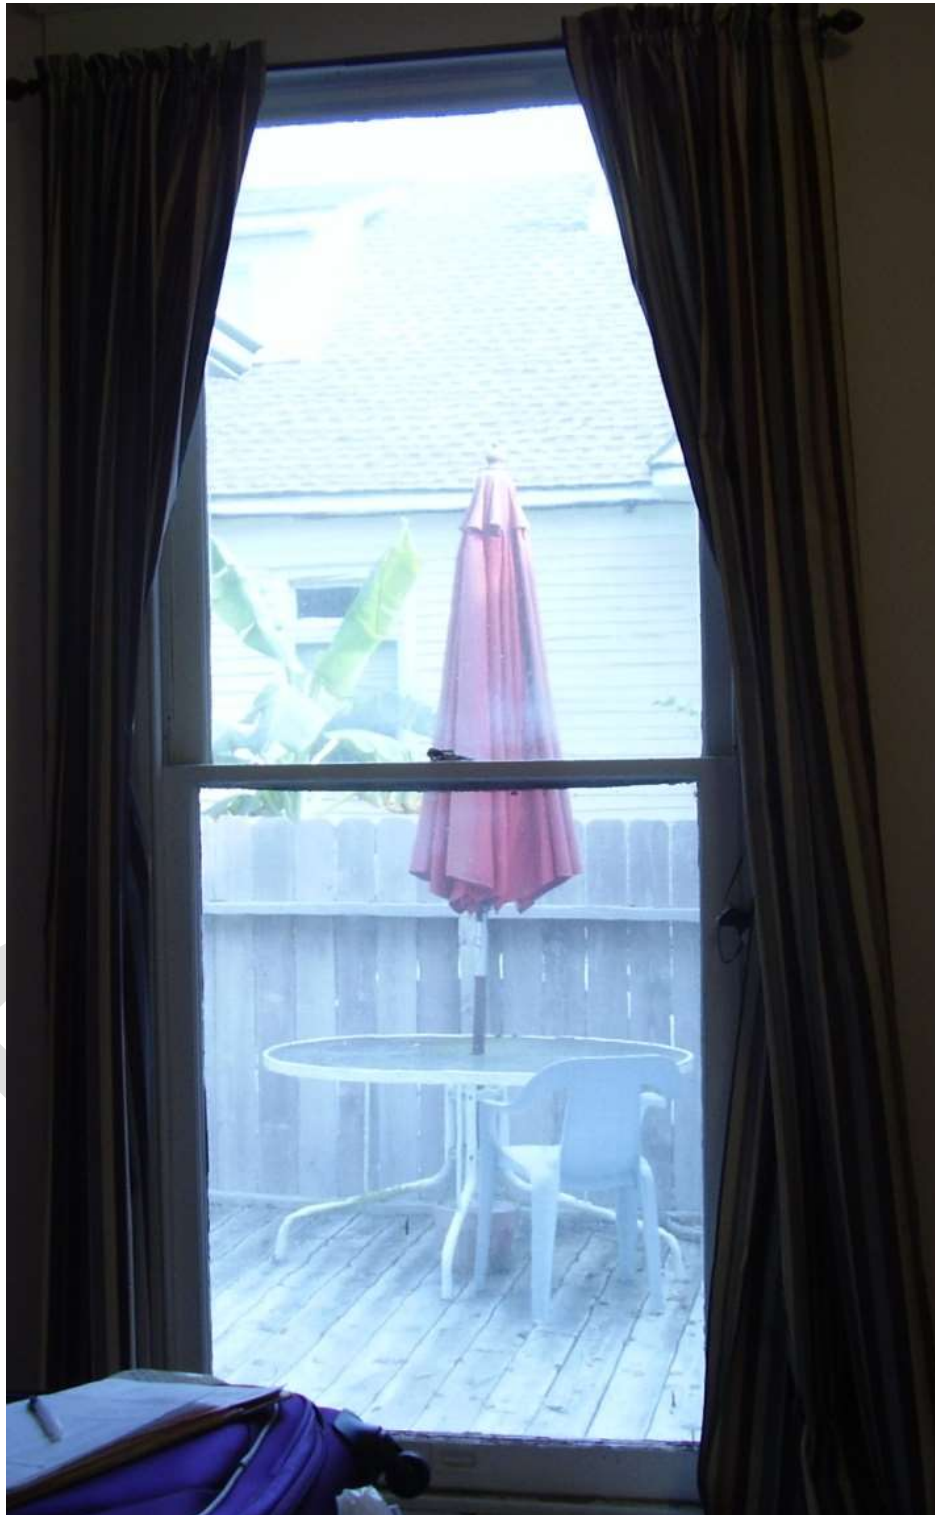
Window 116

Unit # 116 Bedroom 2 - Sash are rotted Lead paint is peeling. Window doesn't open and window is boarded up. Homeowner has lost the use of this room as a bedroom, pending the approval of this project and this has presented a hardship in the sleeping arrangements in the home. Significant damage to the sill and sub sill due to past water intrusion. This is causing additional components of the home to be damaged needlessly.

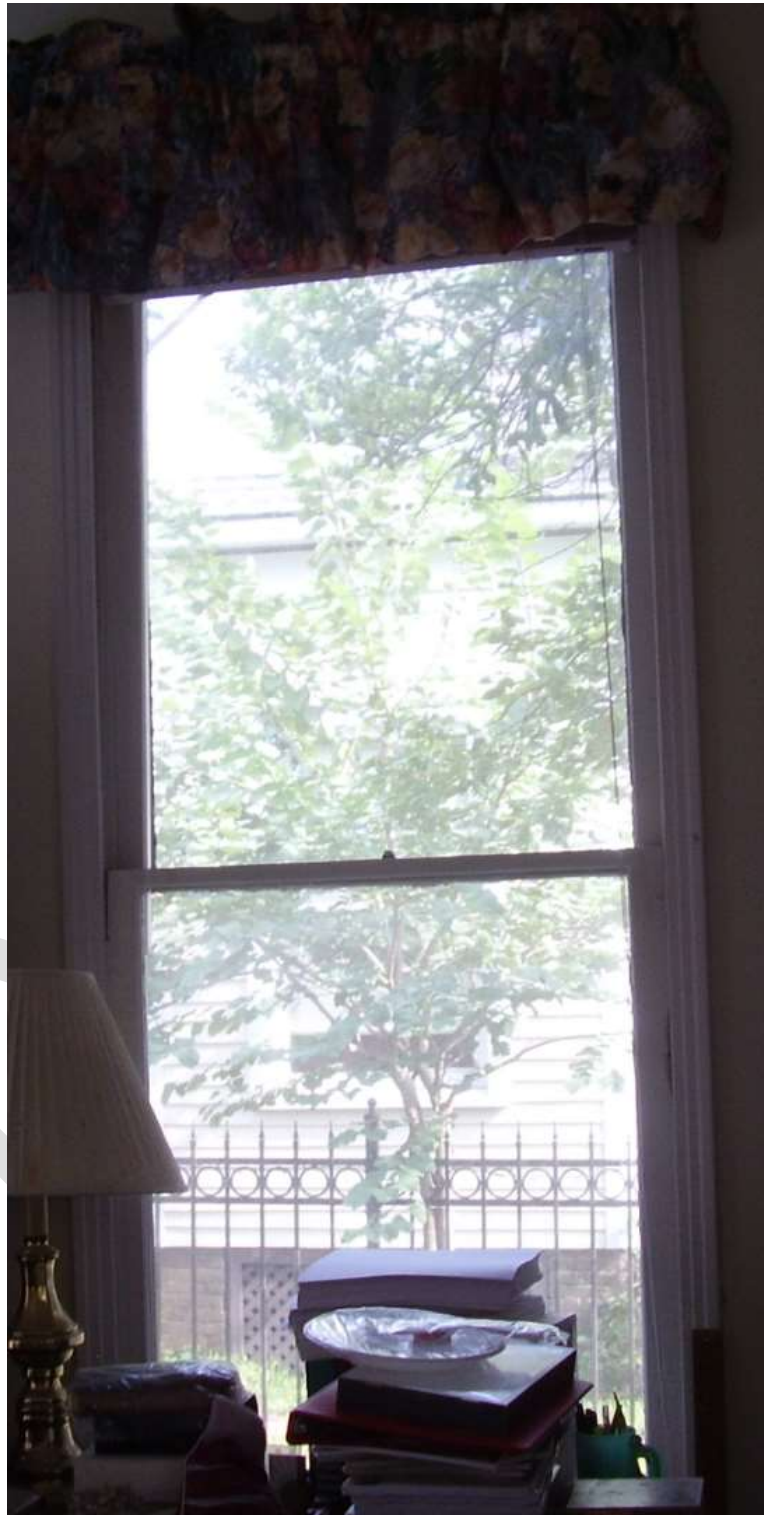
Window 119

Unit # 119 Bedroom 3 - Sash are rotted, lead paint is peeling. Window does not open as designed. Check rail does not align.

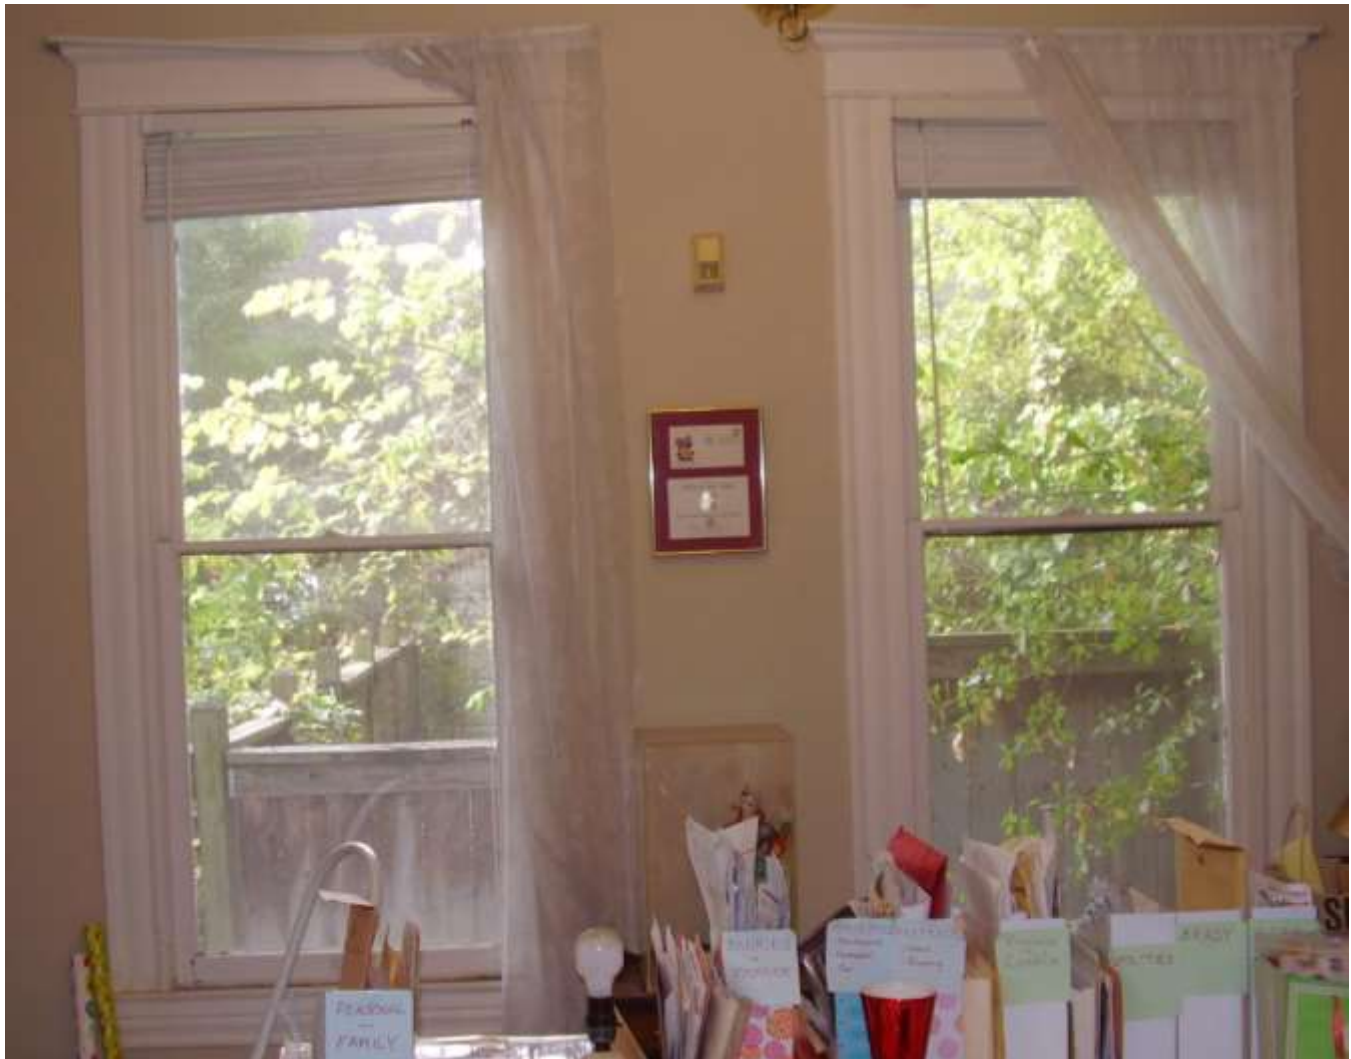
Windows 107 & 106

Unit # 106 Dining Room- Sash are rotted, Lead Paint is peeling. Window cannot be locked and will not open due to being out of square. Check rail does not align.

Unit # 107 Dining Room – Lead Paint is peeling. Sash are rotted. Window cannot be locked and will not open due to being out of square. Check rail does not align

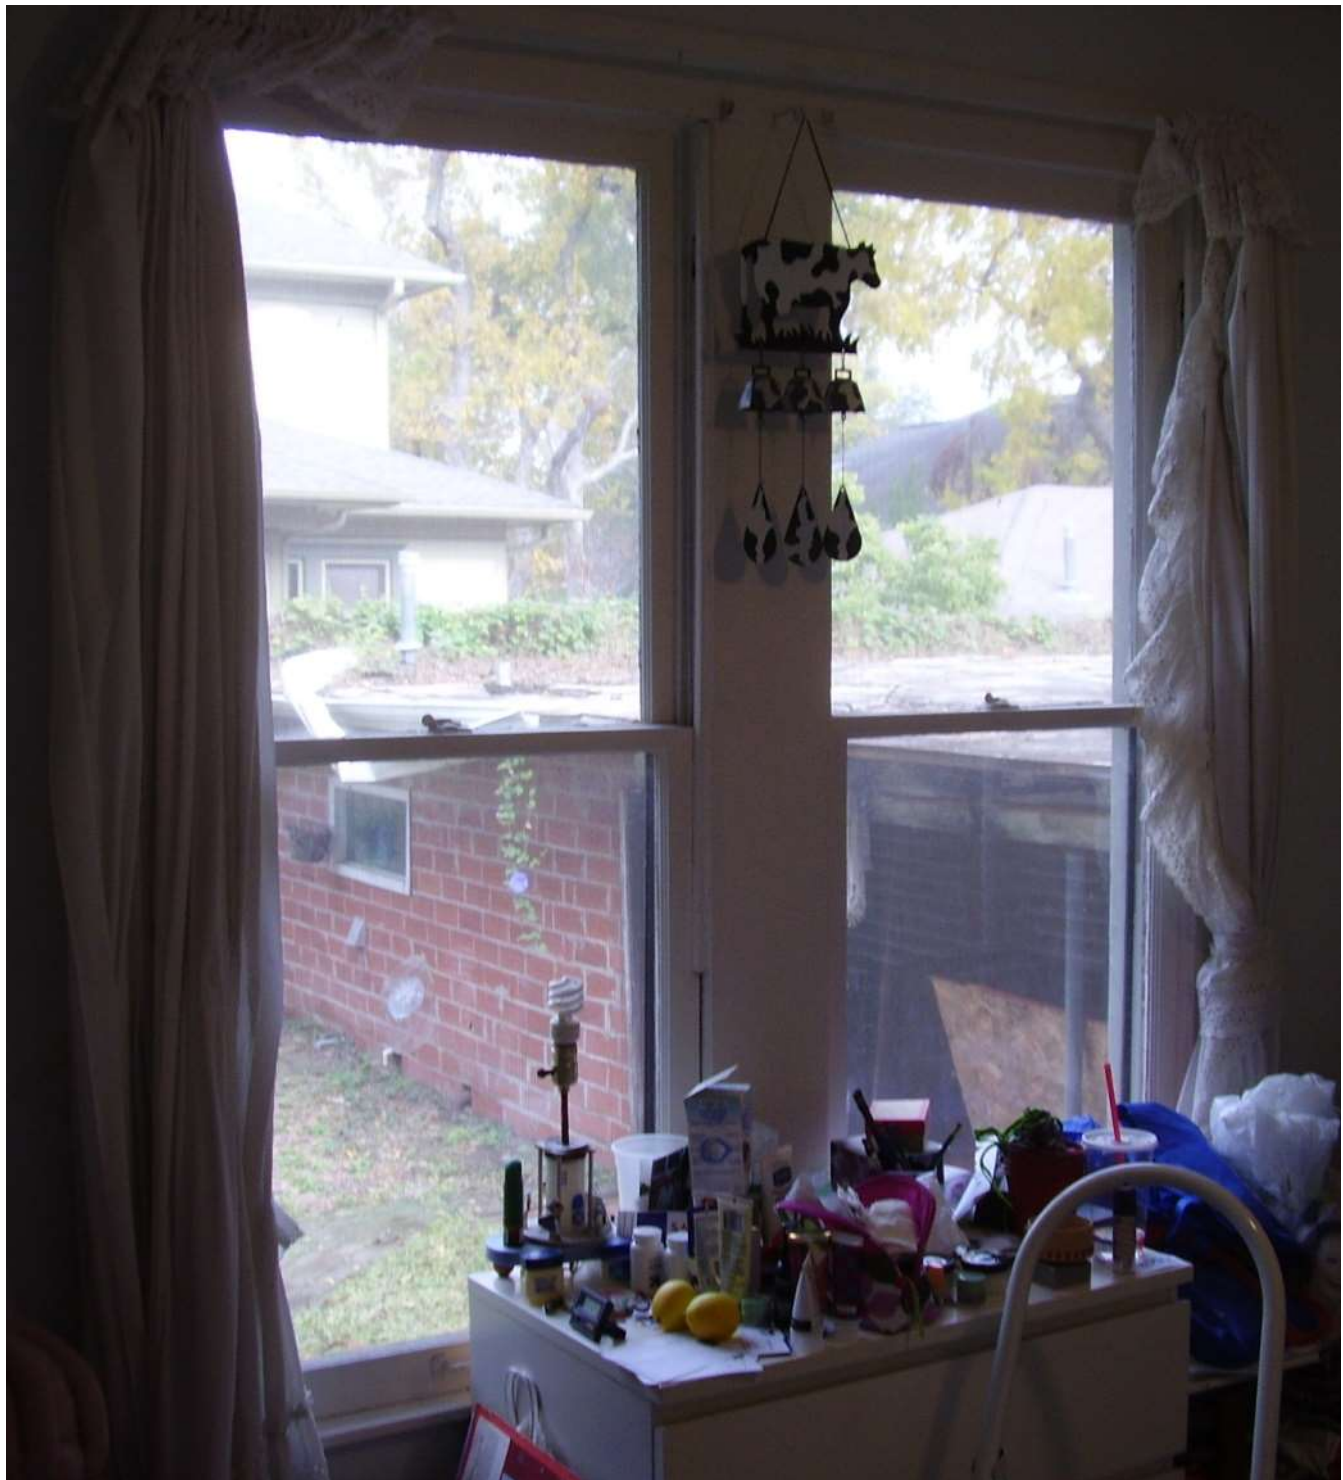
Windows 112 & 113

Unit # 112 Bedroom 1 - Sash are rotted, Lead Paint is Peeling. Window cannot open Glass has a hole in it from some sort of impact (Fire Hazard egress Issue) Dirt on check rail is indicative of massive infiltration of airborne particulate due to poor seal.

Unit # 113 Bedroom 1 – Lead Paint is Peeling, Sash are rotted. Window cannot open (Fire Hazard egress Issue)

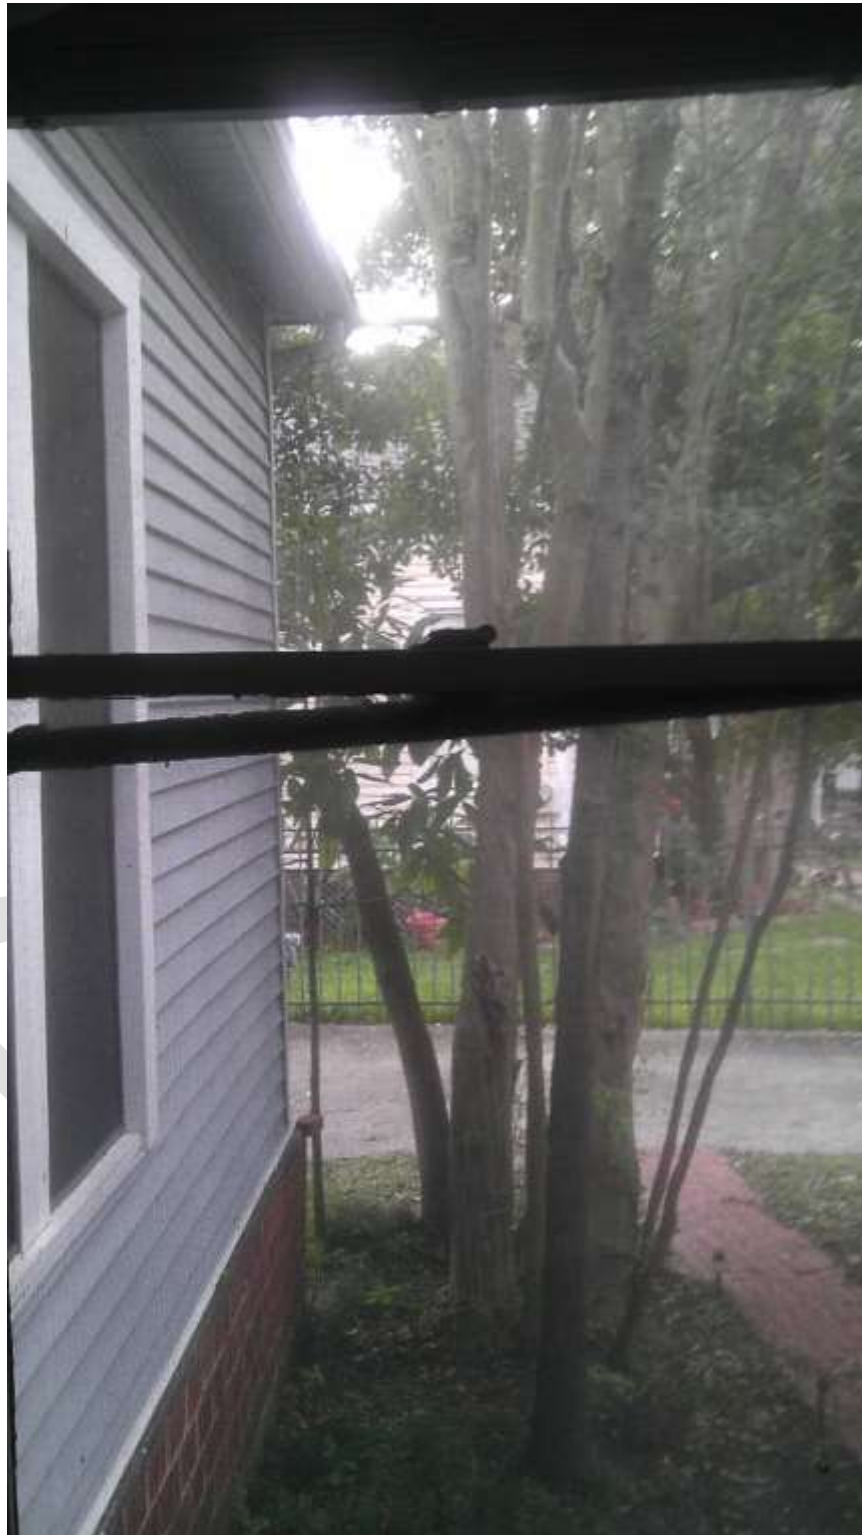
WINDOW 101

Side Elevation: Replace five 1-over-1 sash windows with five 1-over-1 replacement sash windows.
(East) Window 101 has a sagging meeting rail.

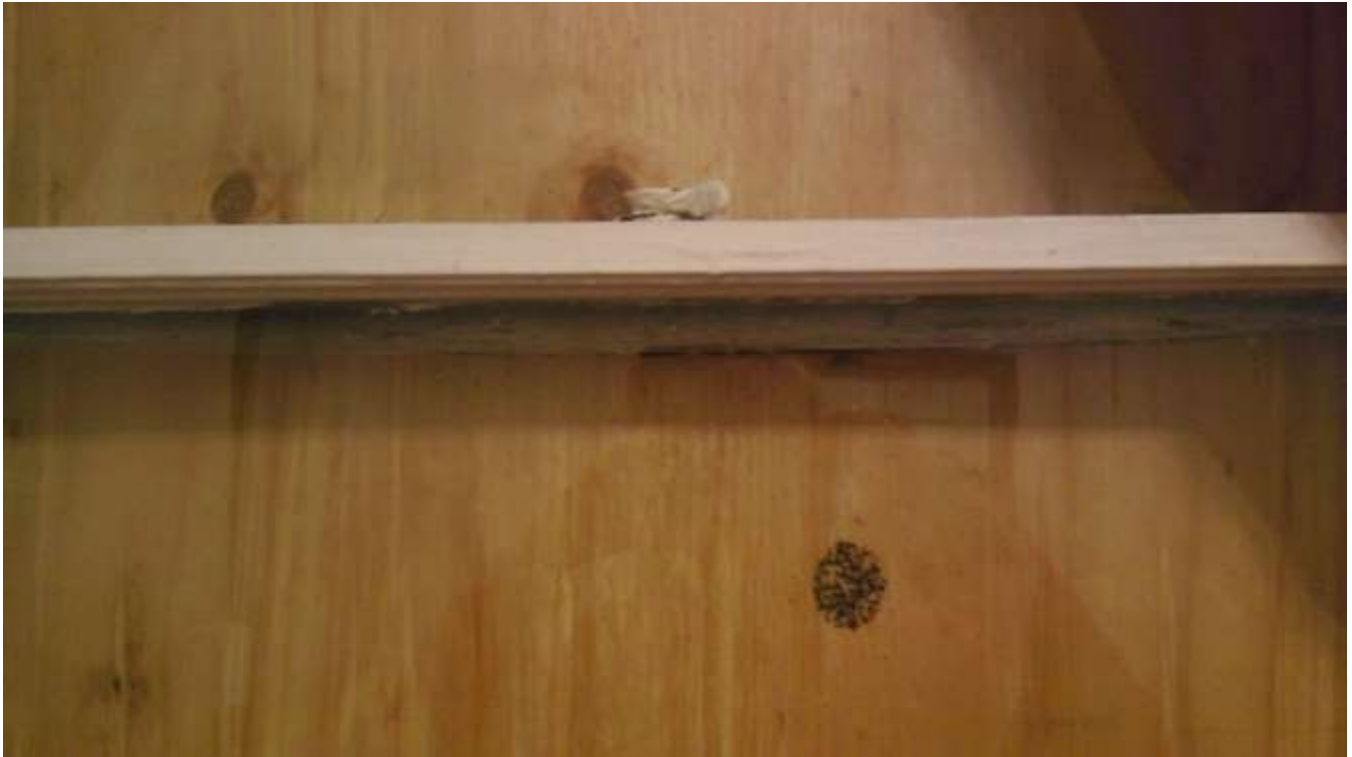
Window 117 has a sagging meeting rail and window 222 shows signs of rot on the bottom sash.
